Clacton and Holland Beach Hut Association

Jeremy Shiers

27 October 2012

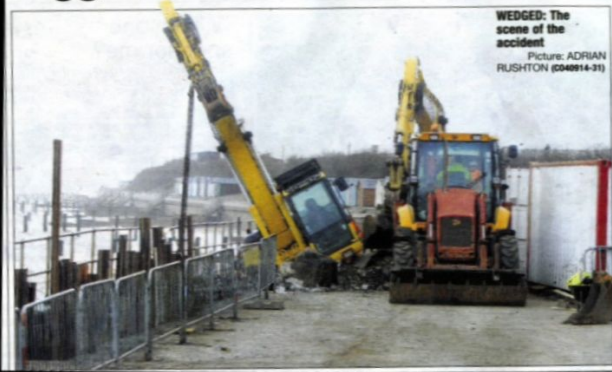
WEDGED: The scene of the accident

A LARGE digger was left balancing on a knife-edge when it slipped into a hole.

The excavator fell into the hole on Lower Promenade, Holland-on-Sea, while doing improvement work to a section of sea wall near the Gunfleet Boating Club.

John Russell, Tendring Council's assistant head of technical services, said the edge of the concrete slab the machine was running on broke off and one track slipped into the hole that appeared under the promenade.
