# Appendix K – Technical Reports

Performance Review of Rock and Timber Groynes  
Recommendations for Cobbold's Point/ Undercliff Road

# **Performance Review of Rock and Timber Groynes**

**June 2009**

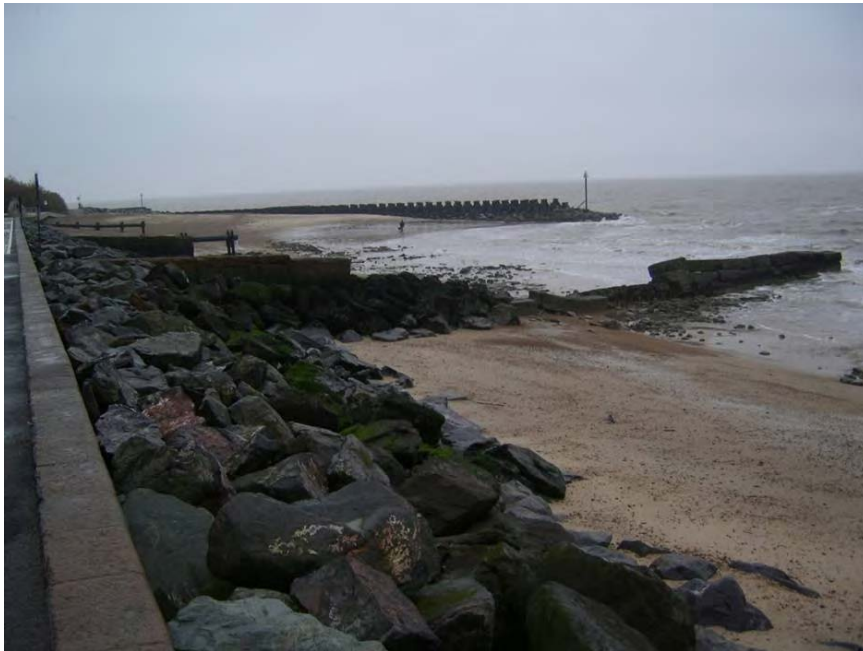
**Figure 1-2 Collapsed concrete encased timber groyne and lowered beach levels outside the Fludyer's Arms (February 2009).**

According to anecdotal evidence the beach levels at Cobbold's Point constantly fluctuate. The general trends indicate that the beach level has been dropping since the recharge was placed following the Cobbold's Point installation. Surveys undertaken by Halcrow in 2001 and Mott MacDonald in 2009 show a beach level drop of 2.8m since 2000. Along the frontage between Cobbold's Point and the War Memorial the beach levels are also dropping, especially to the south of the southern fishtail groyne at Cobbold's Point. Between 8<sup>th</sup> and 9<sup>th</sup> October 2002 a strong easterly storm resulted in the beach levels outside the Fludyer's Arms dropped by 2.65m (Terry Oakes Associates Ltd, 2002) (see Figure 1-2). This drop in beach level resulted in emergency work been undertaken to place rock armour in front of the seawall to stabilise it.

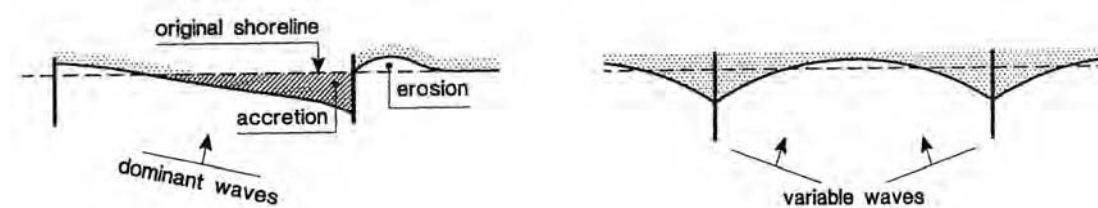
**Figure 2-1 Shoreline position inside groyne compartments (left = single dominant wave direction, right = variable wave direction) (from Van Rijn, 2004).**

In providing a physical barrier to longshore transport, groynes are intended to alter the orientation of the beach to be more closely aligned with the incoming wave crests<sup>3</sup>. On coasts with a dominant wave approach, sediment is deposited on the updrift side of the groyne whilst erosion occurs in the lee of the structure. Consequently, there is often a step-type difference in elevation across each groyne. On coasts with a highly variable wave climate, a curved, bay-type beach will form<sup>4</sup>. Examples of the shoreline position within groyne compartments are shown in Figure 2-1.

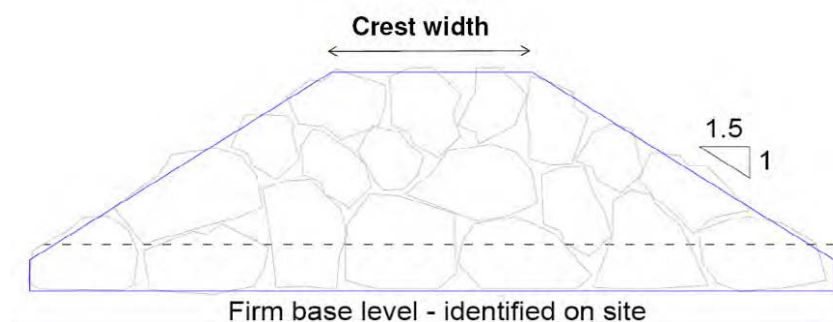
**Figure 2-2 Typical cross section of a rock groyne**

Rock groynes are typically long structures which extend past the Low Water Mark. Rock groynes are generally founded between 1.5m and 2m below the beach level, therefore having a larger footprint than can be seen from the beach<sup>8</sup>. Beach material is trapped between the groynes as it moves along the coast. However, material can also become trapped in the voids between the rocks causing the hydraulic performance of the rock groynes to diminish. Along the Felixstowe frontage between Cobbold's Point and the War Memorial it is proposed that the length of the groynes would be between 45m and 70m. The spacing of the groynes will be determined through subsequent analysis of survey data and numerical modelling.

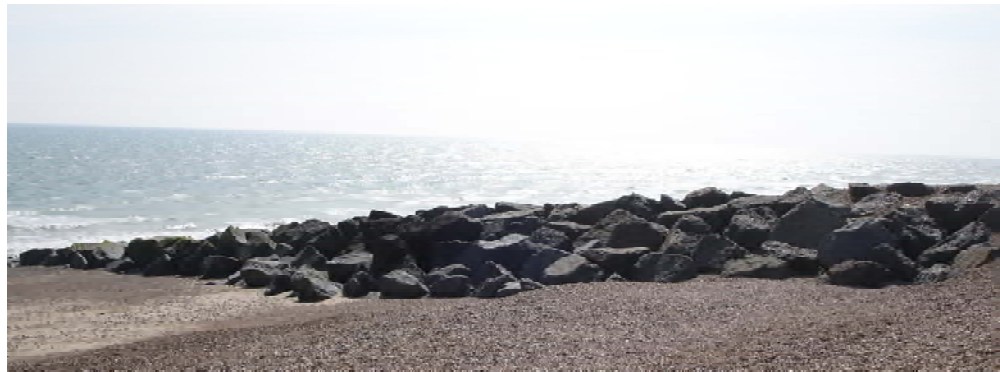
**Figure 2-3 Rock groyne at Shoreham-on-Sea (May 2009)**

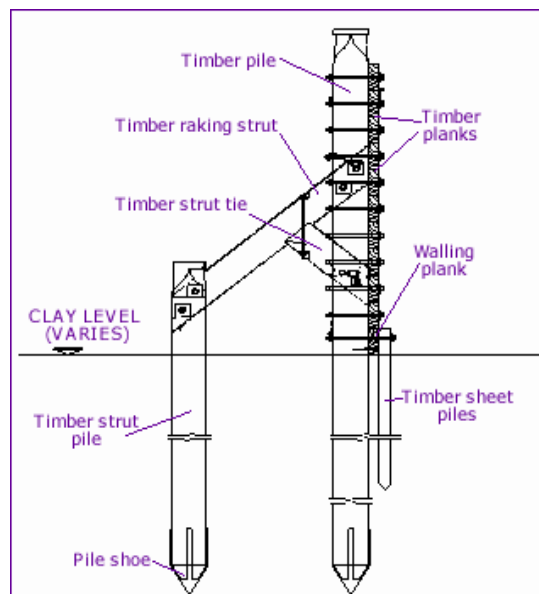
**Figure 2-4 Typical cross section of a timber groyne** (source:  
<http://www.canterbury.gov.uk/buildpage.php?id=168>)

Timber has been the traditional method for groyne construction in the UK. The benefits of using timber are that it is relatively lightweight and has a good strength to weight ratio. However, timber can also contain natural flaws and the required length of timber needed for groynes is available in limited quantities. Timber groynes can also be susceptible to damage by biological attack and abrasion. Above the beach level timber can be damaged by fungal decay and rot, whilst below the beach level marine borers can cause damage.

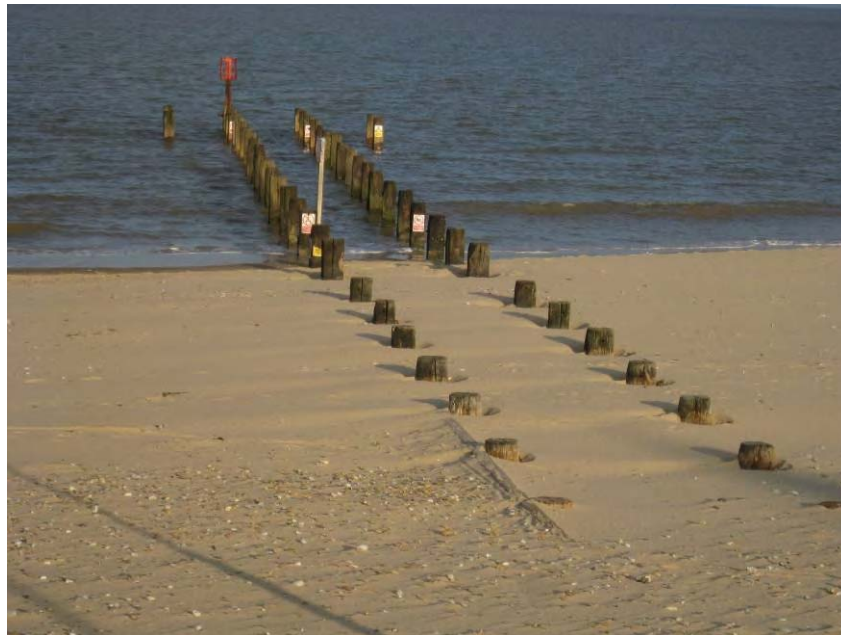
**Figure 2-5 King piles on Lowestoft beach (21/05/2009)**

Timber groynes are adaptable in terms of adding and removing planks, allowing the level and profile of the groynes to be altered and maintained. The alteration of the planks can also control the passage of sediment longshore. However, the spacing of the groynes cannot easily be altered once they are constructed. Any groynes that were constructed in along the Central Felixstowe frontage would need to be piled into the London Clay making the removal of them costly compared to rock groynes. On amenity beaches timber groynes have a small footprint and are generally perceived to be more aesthetically pleasing when compared to rock groynes<sup>9</sup>. The design and detail of timber groynes affect the performance and durability of the groyne. Conventional straight timber groynes as presented in Figure 2-4 are constructed using piles and planking and often sheet piles to provide resistance to ground and wave forces. Other groyne types can include permeable pile screens and double or single rows of timber piles as presented in Figure 2-5. Permeable pile screens have been reported to be less effective at retaining a beach, but result in less severe erosion downdrift<sup>10</sup>. King pile groynes, which consist of timber piles constructed in a row next to each other too enable sheet piling beyond the low water mark are present at Lowestoft.

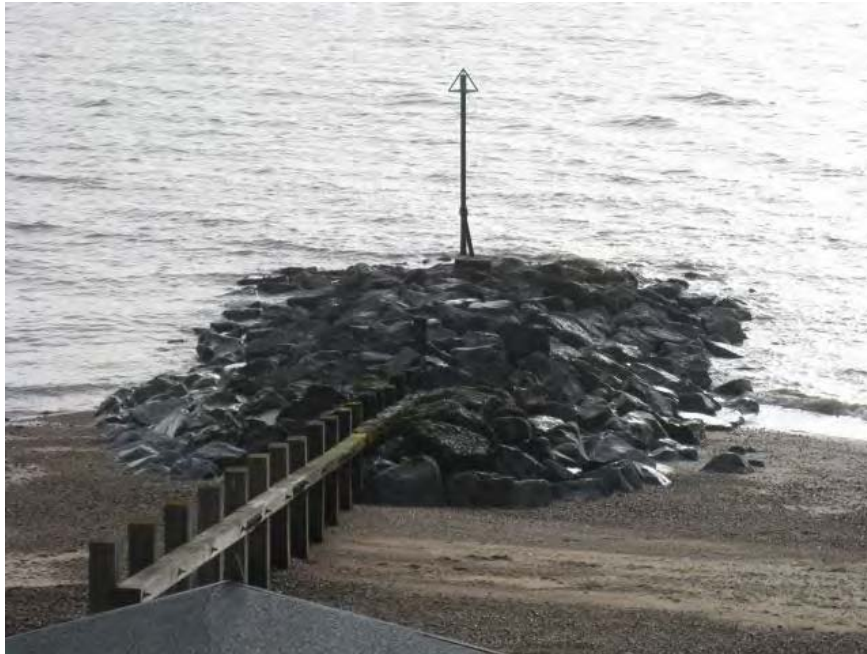
**Figure 2-6 Hybrid groyne at Brackenbury, North Felixstowe (February 2009)**

Hybrid groynes are constructed with a timber section at the landward end and a rock section at the seawards end of the groyne. The principle of a hybrid groyne at the seawards end works in a similar way to a rock groyne by dissipating the wave energy. The rocks at the seawards end of the groynes require less maintenance compared to timber and therefore require less frequent replacement.

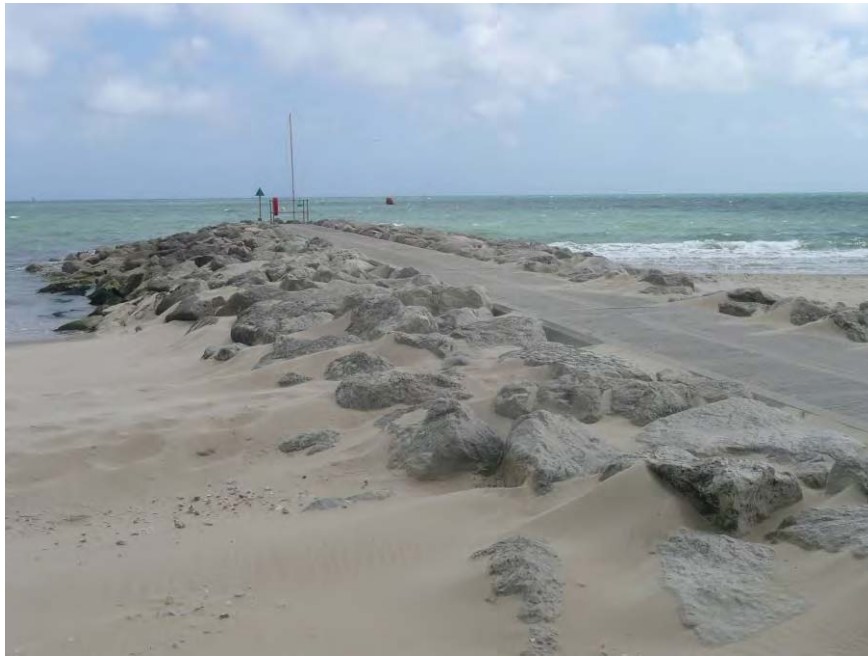
**Figure 2-8 Flat concrete walkway on top of a rock groyne at Poole (18/05/2009)**

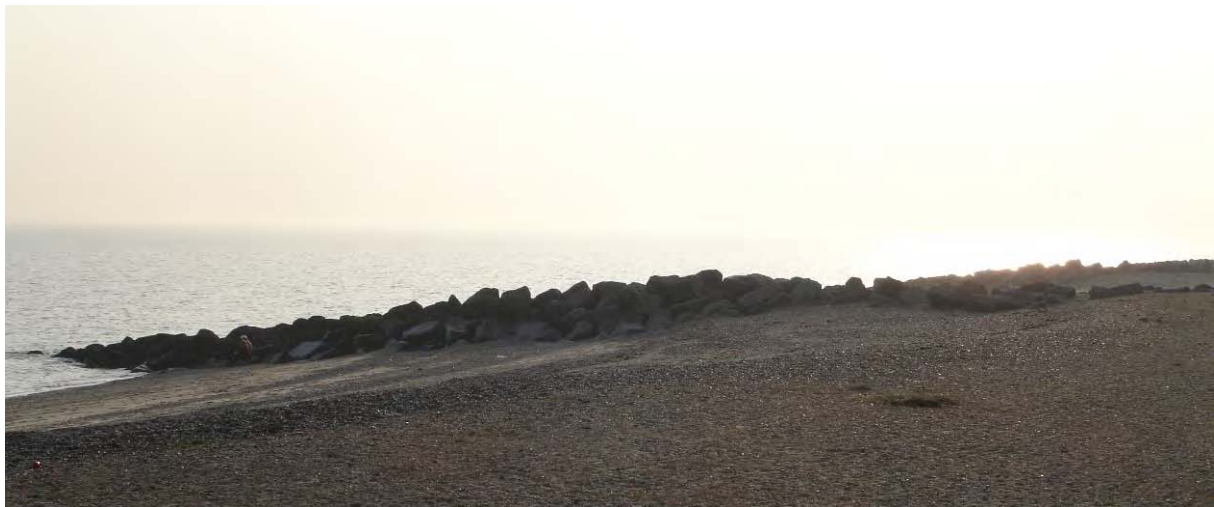
**Figure 2-9 Rock groynes at Jaywick (May 2009)**

At Jaywick is a steep shingle beach with a series of rock groynes that were constructed approximately 10 years ago. The groynes are approximately 1.5m high, 70m long, and 75m spacing (L/S ratio 1.07).

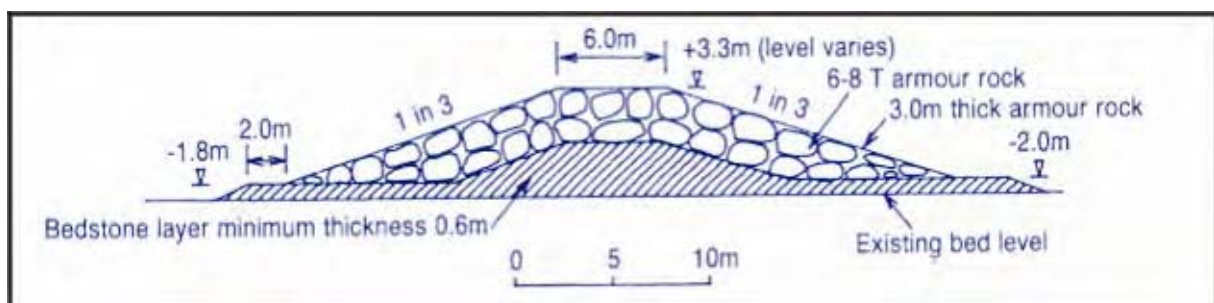
**Figure 2-10 Cross section through the a rock groyne at Jaywick**

A cross section through the rock groynes at Jaywick is presented below (Figure 2-10)

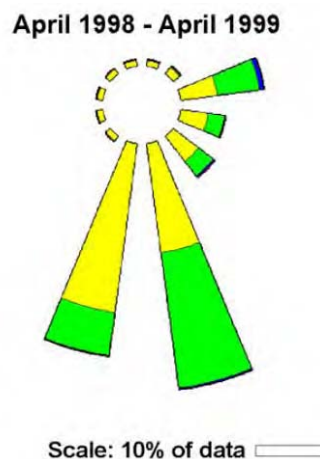
**Figure 2-11 Wave Rose for inshore waves at South Felixstowe (source: Halcrow 2003<sup>13</sup>)**

The rock groynes at South Felixstowe were constructed in 2008 with a length of between 30m and 50m. The beach material is mixed, consisting mainly of sand but with some shingle. The rock groynes were constructed with the landward 10m of groynes being buried beneath the beach to improve the visual amenity of the beach. The decision to construct rock groynes included a number of environmental enhancements including the ability for users to walk along the beach and that an open beach would be created as a result of the wider spacing of the rock groynes. It has been observed that the rock groynes are being used as a windbreak by beach users. The prevailing wave direction along the frontage is from the south and south east. The inshore height of the waves varies between 0.5m to 3m.

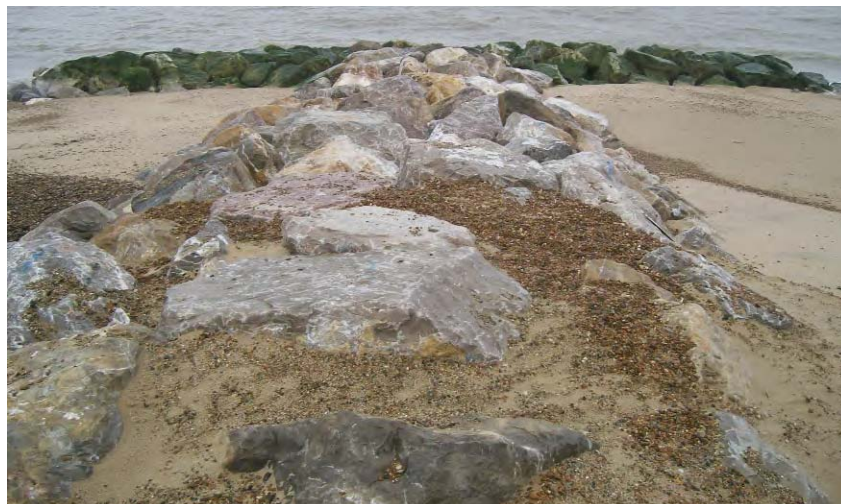
**Figure 2-12 A T head rock groyne at South Felixstowe (October 2008)**

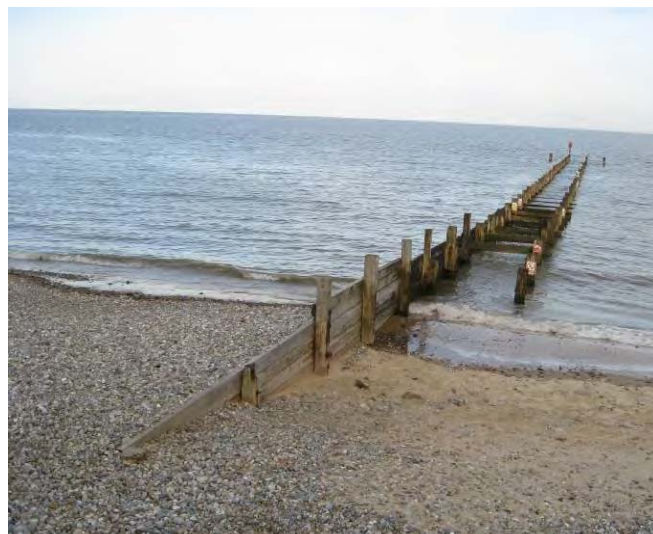
**Figure 2-14 Pile-group Kingpile timber groynes at Lowestoft. A dual row of king piles is used to create an access platform for piling plant, allowing construction of groynes below the low water mark. Photograph taken 21/05/09**

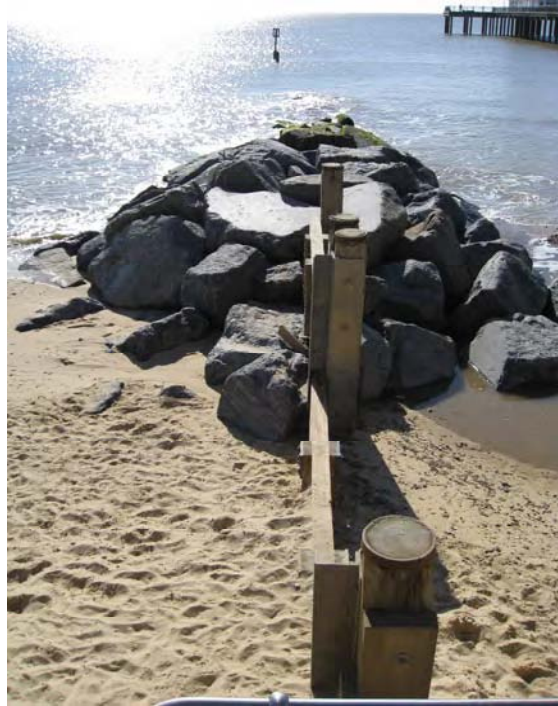
**Figure 2-15 One of the 2005 rock groynes at Southwold. The rock groynes were carefully constructed to reduce the voids between the rocks in an attempt to reduce health and safety issues. The head of the groyne at the seawall has removable timber struts to enable access. Photograph taken 22/05/09**

A £7 million groyne scheme funded by Waveney District Council and the Environment Agency has recently been constructed in Southwold. Within the scheme a field of rock groynes have been constructed to the north of the pier which have been successful in trapping sediment and holding a stable mixed sand and shingle beach. The rock groynes are 45m in length with a 70-80m spacing (a 1:1.8 length to spacing ratio) and cost approximately £200,000 per groyne to construct. The scheme has been successful in maintaining the mixed sand and shingle beach.

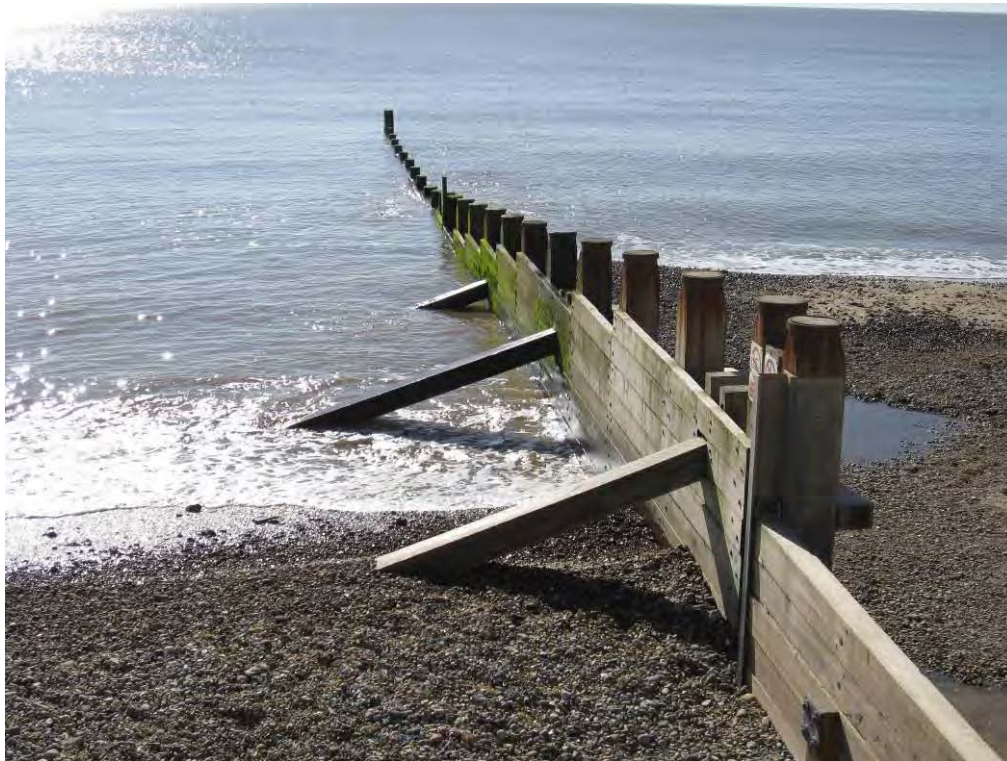
**Figure 2-16 – A 2005 timber groyne at Southwold. Similar to the rock groynes to the north the timber groynes also have removable struts near to the seawall allowing access. Photograph taken 22/05/09**

In the aggressive wave and current climate at Southwold, the life of these groynes is unlikely to exceed 20 years even with the regular monitoring and extensive maintenance described in detail in Section 3.3 (Paul Patterson, personal communication).

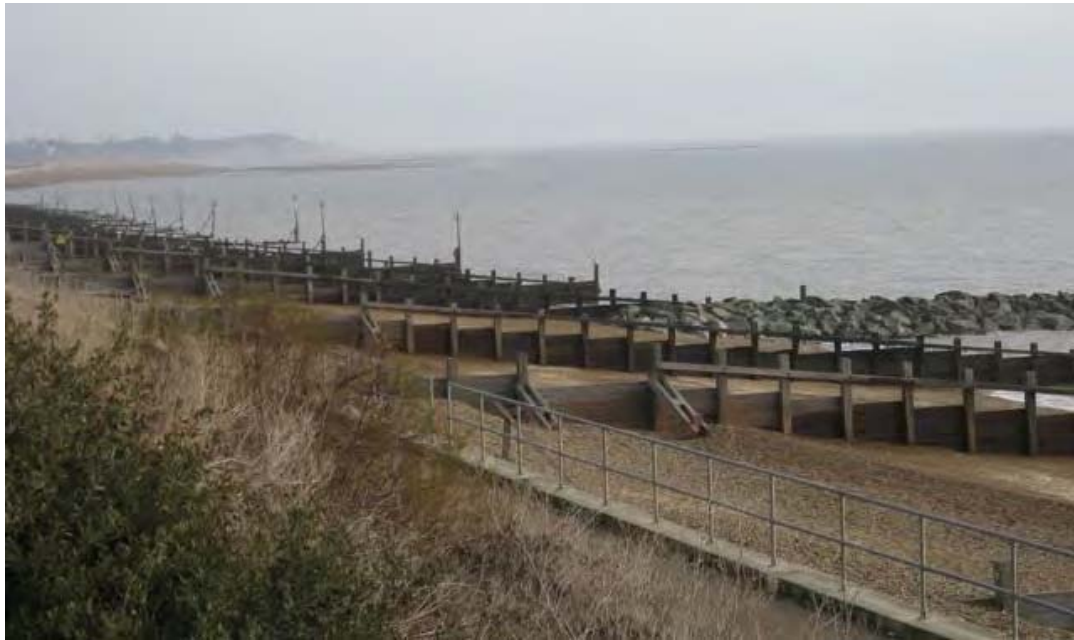
**Figure 2-17 Timber groynes in the distance with Hybrid groynes in the foreground at Brackenbury (February 2009)**

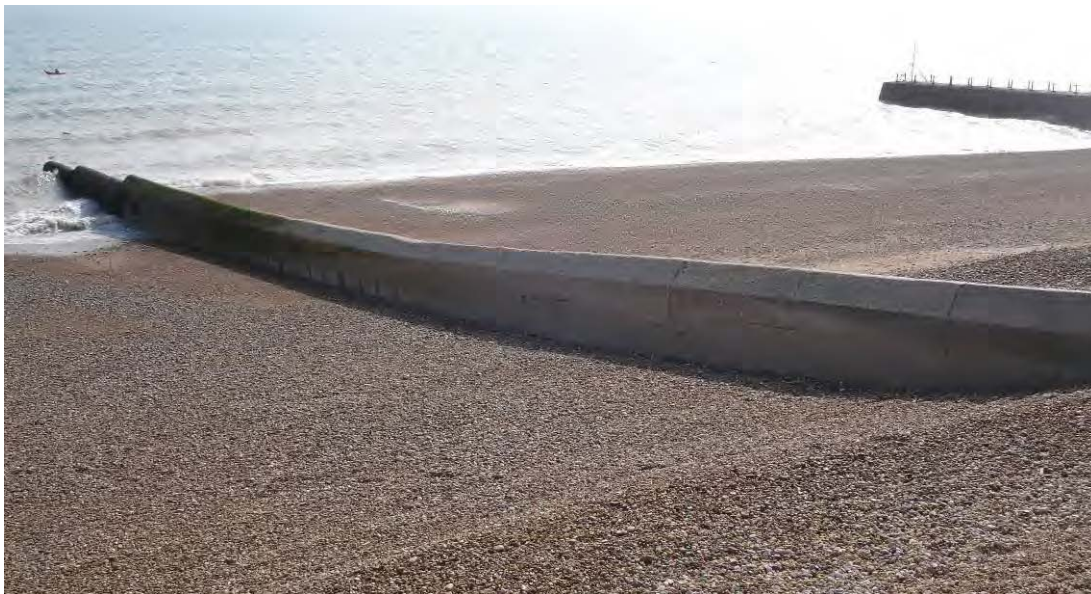
**Figure 2-19 Concrete groyne at Brighton beach (May 2009)**

A condition survey undertaken in 2000 indicated that most of the groynes were generally in good condition. However, the foundations of the groynes had started to become undermined. These groynes required immediate attention to prevent them from falling over.

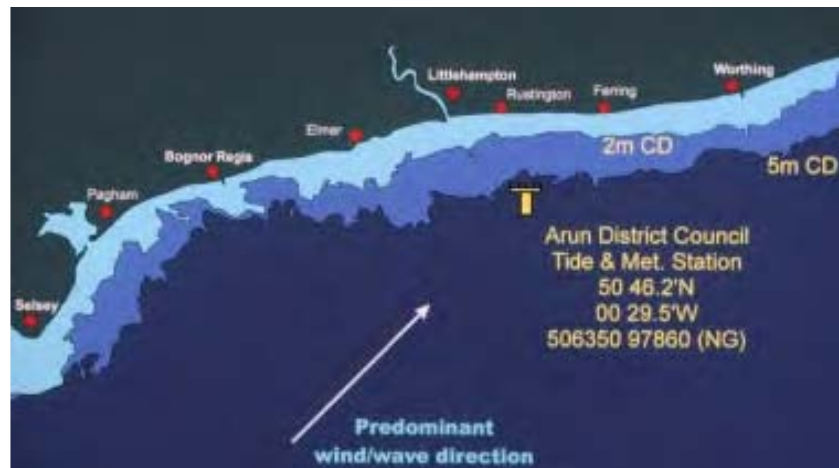
**Figure 2-20 Predominant wind/wave direction** (www.arun.gov.uk)

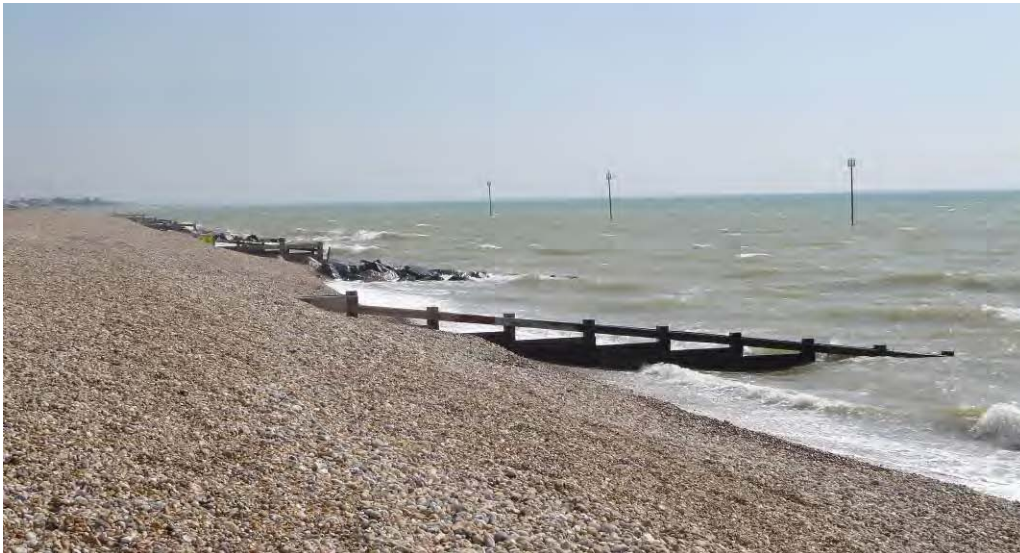
**Figure 2-21 Hybrid groynes at Bognor Regis (May 2009)**

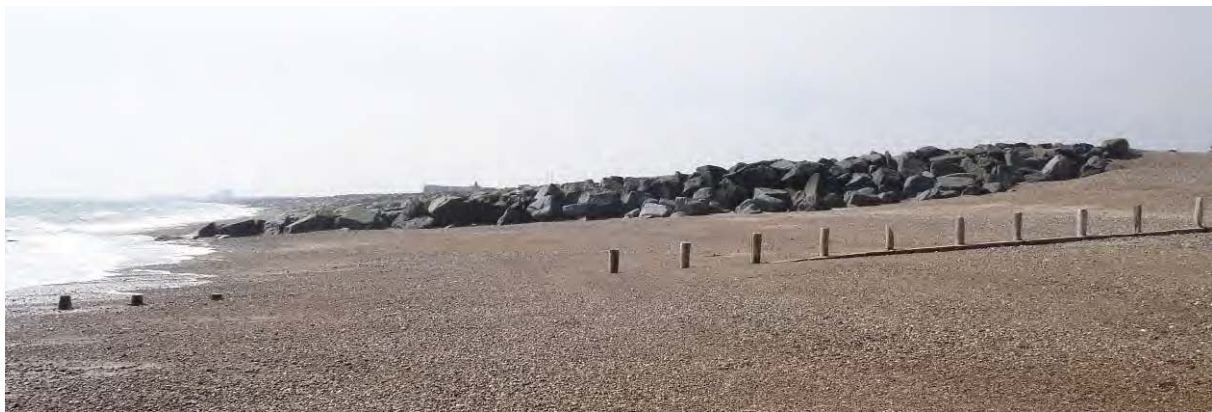
**Figure 2-22 New rock groynes constructed alongside timber groynes at Shoreham-on-Sea (May 2009)**

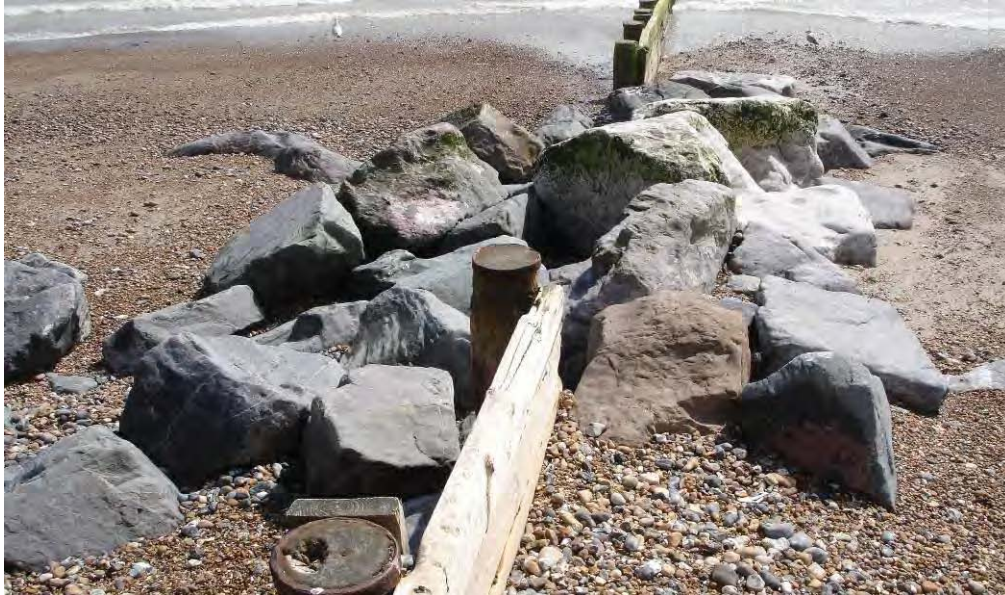
**Figure 2-23 Repairs to a timber groyne at Worthing (May 2009)**

At Worthing the coastal defences were constructed in 2000. The design of the scheme took into account information derived from a coastal monitoring scheme. The orientation of the groynes was between 230 and 250 degrees North based on the longest fetch and largest waves. From observations from the existing groynes a length of 55 m was adopted with 1 to 1 spacing. It was also observed that a 15m berm was required to prevent flooding by overtopping. A hybrid groyne design was decided upon for this location owing to past experience had indicated that the marine borers and rot affected the groyne. Rock filled gabions were placed at the seawards end of the groyne. In 2001 it was reported that the gabions were working well and were allowing beach movement<sup>19</sup>.

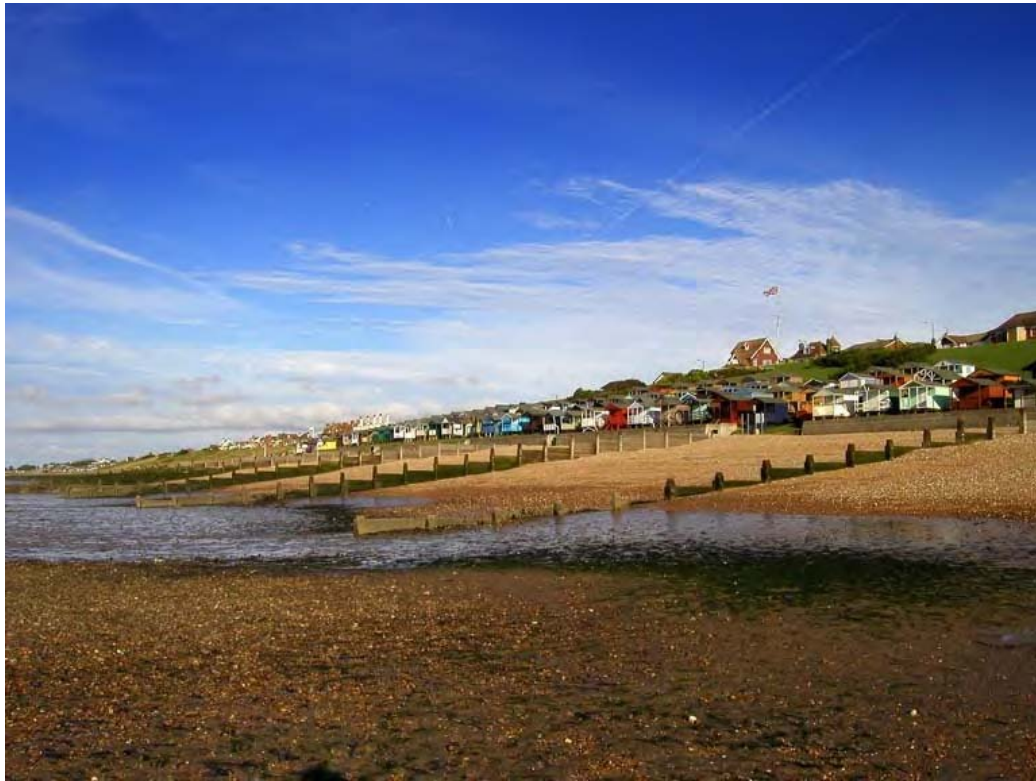
**Figure 2-25 Timber groynes at Tankerton** ([www.kent.ac.uk](http://www.kent.ac.uk))

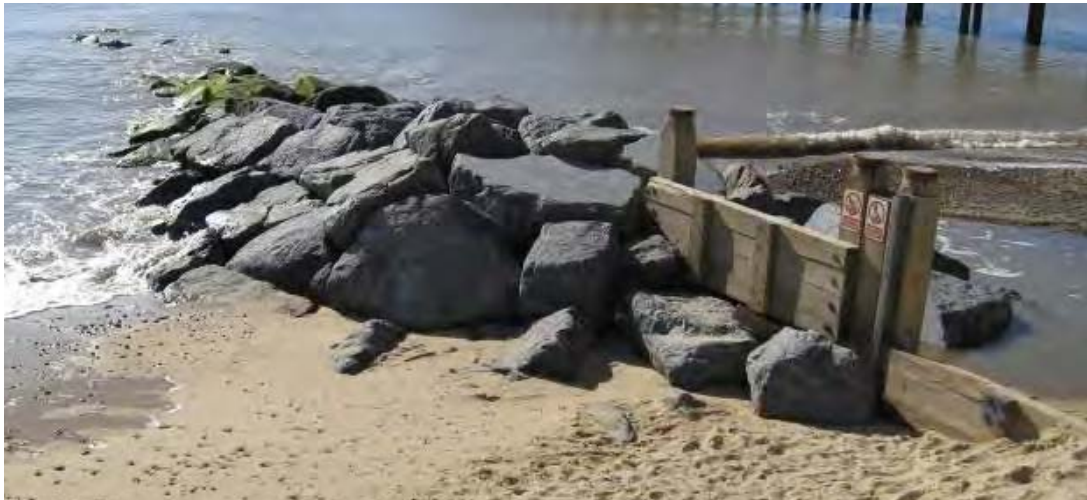
**Figure 4-1 Closely spaced rocks preventing large voids in the rock groynes**

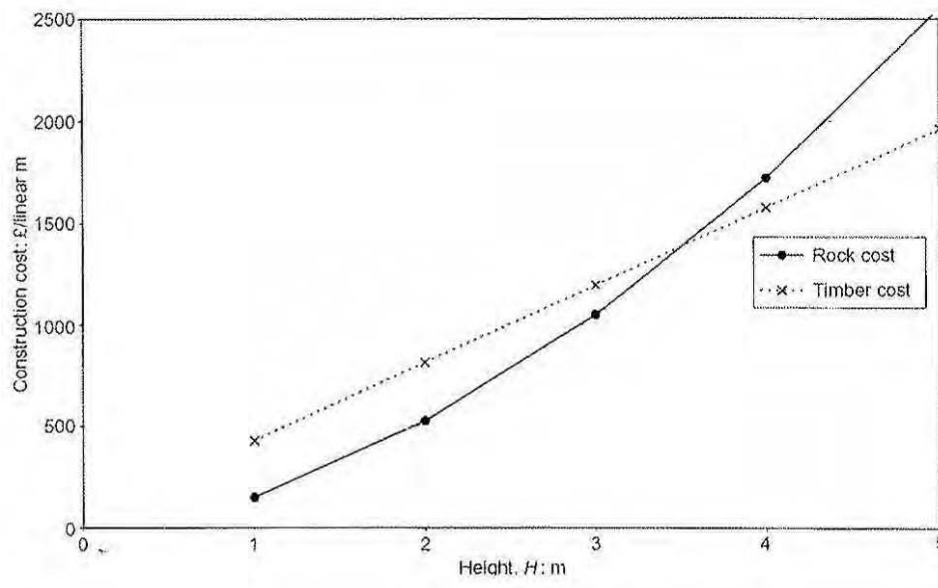
The variation of height and cost of rock and timber groynes is presented in Figure 6-1. Figure 6-1 indicates that below a groyne height of 3.5m the construction cost to cost per linear metre ratio was lower for rock groynes compared to timber groynes. However, if the groynes are constructed above 3.5m then timber groynes have a lower construction cost to cost per linear metre ratio<sup>28</sup>.

**Figure 6-1 Variation in costs with height for rock and timber groynes (Crossman and Simms, 2002<sup>24</sup>)**

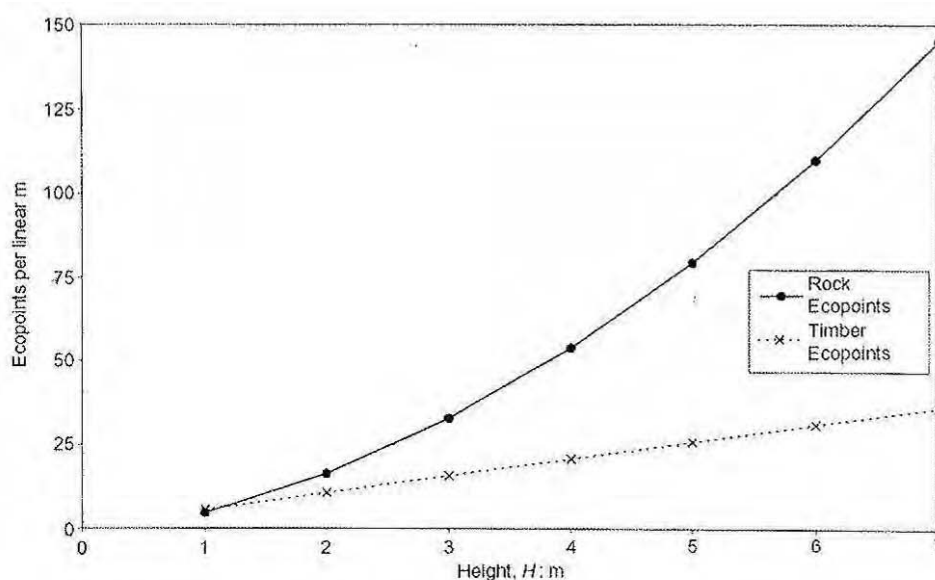
**Figure 7-1 Variation in Ecopoints with height for rock and timber groynes**

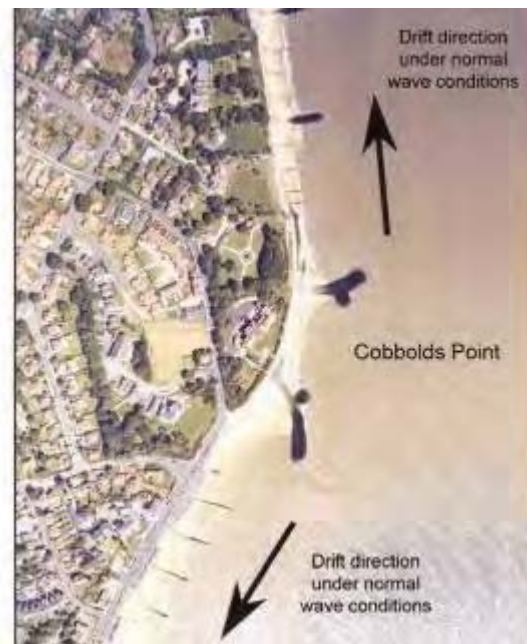
**Figure 1-2 Drift parting at Cobbold's Point (Halcrow 2003)**

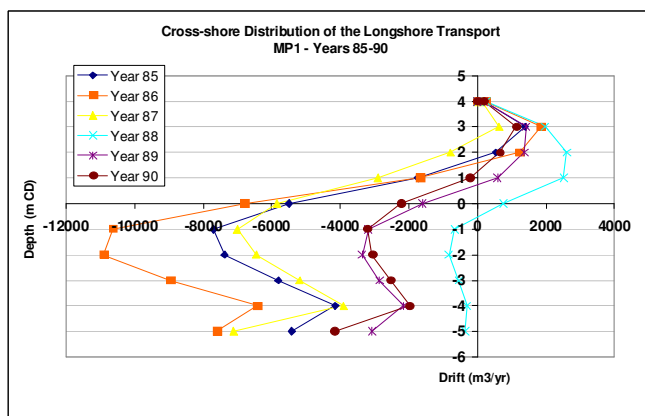
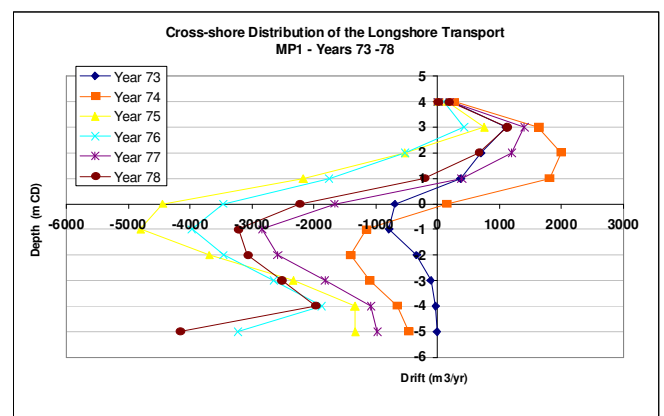
**Figure 1-4 Sediment direction to the north of Cobbold's Point (MP1)**

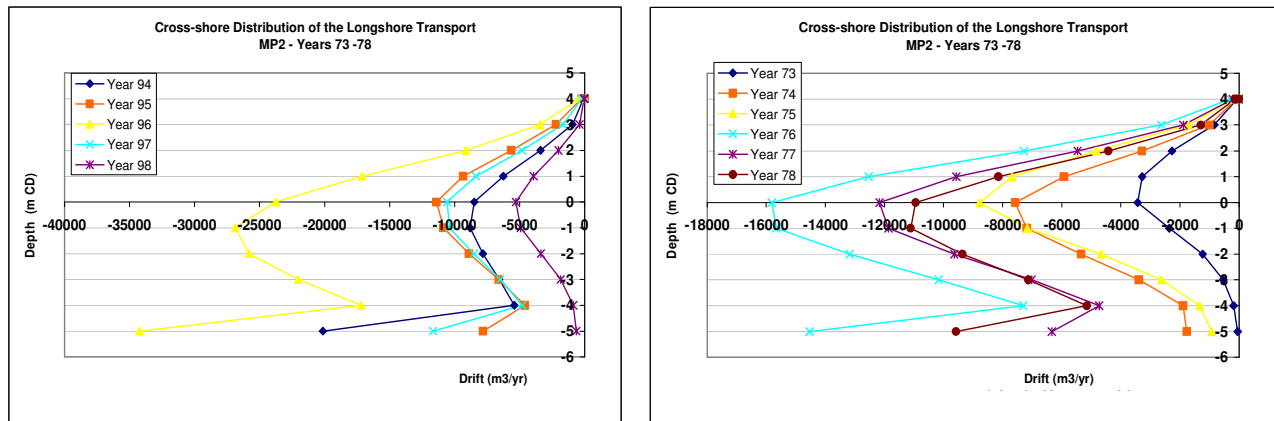
**Figure 1-5 Sediment direction to the south of Cobbold's Point (MP2)**

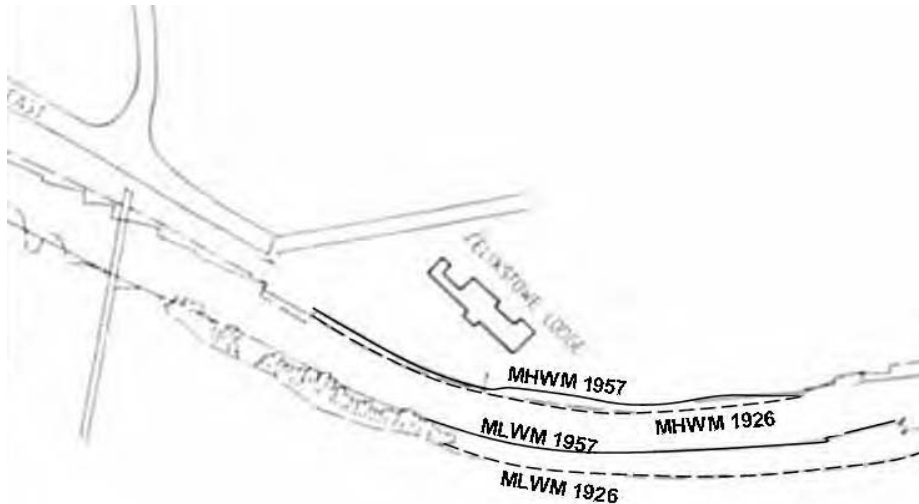
**Figure 1-6 Historical water marks for Cobbold's Point for 1926 and 1967 (Dobbie, 1990)**

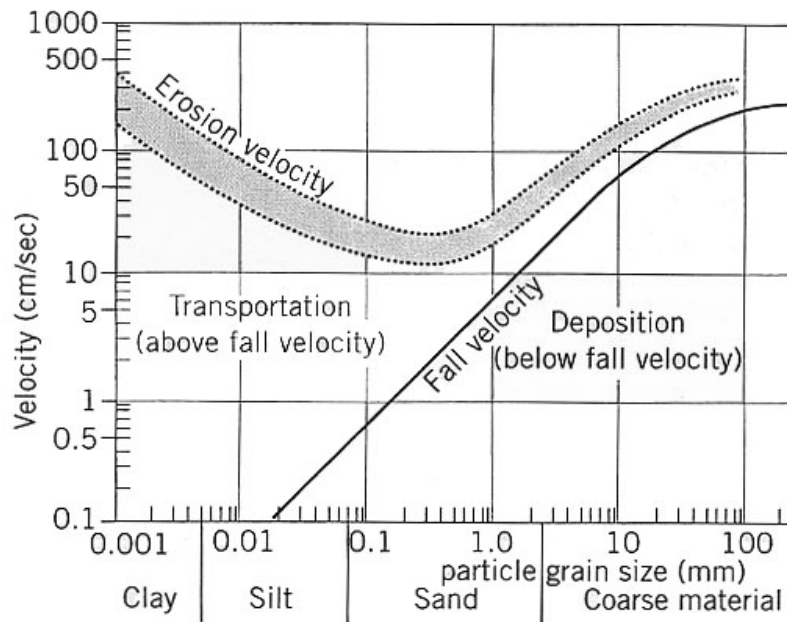
**Figure 1-7 Velocity threshold for sediment transport** (source: [http://www.geographyalltheway.com/ib\\_geography/ib\\_drainage\\_basins/imagesetc/hjulstrom\\_curve\\_task.jpg](http://www.geographyalltheway.com/ib_geography/ib_drainage_basins/imagesetc/hjulstrom_curve_task.jpg))

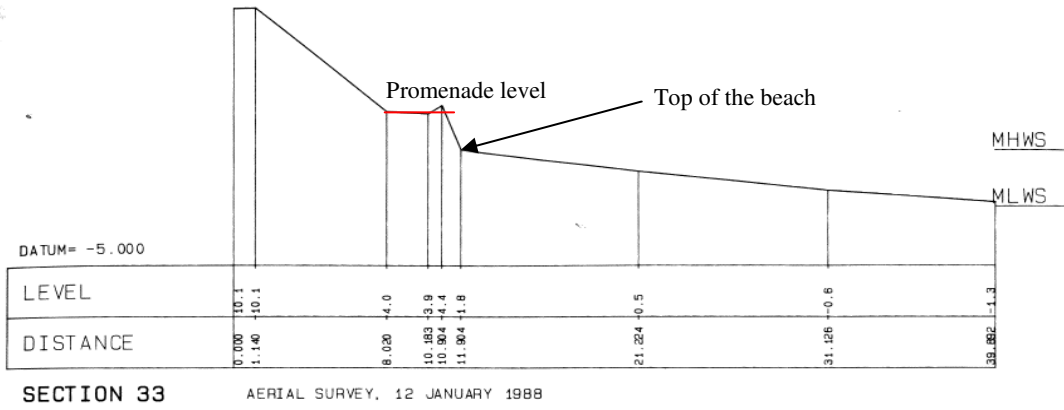
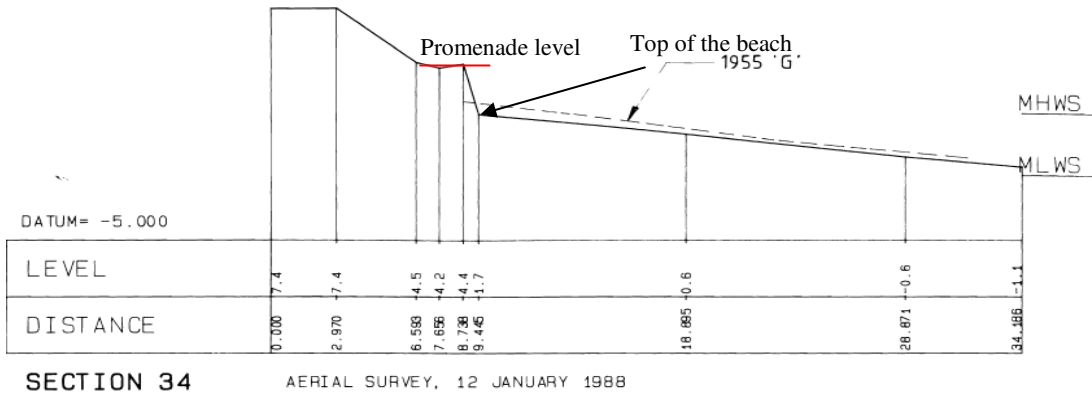
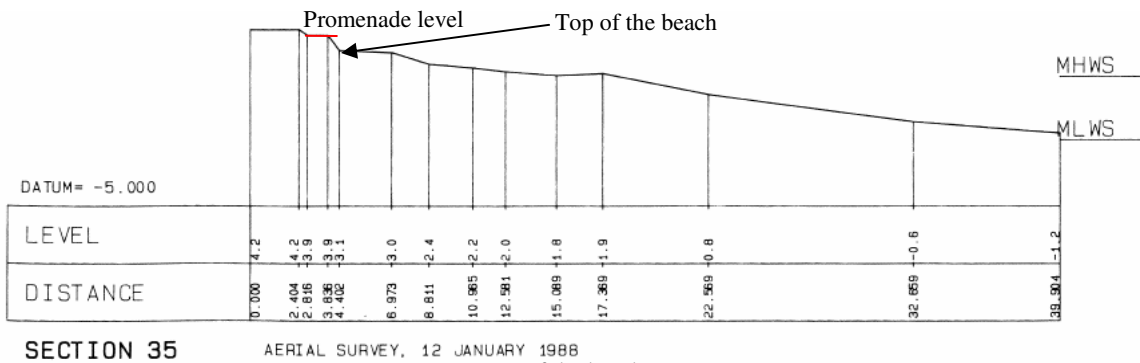
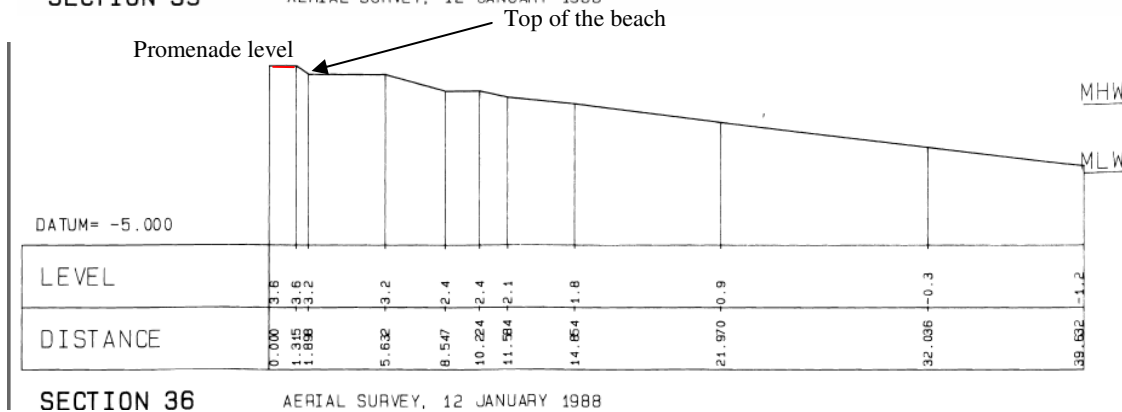
**Figure 1-11 Beach profiles from 1988 (Dobbie, 1990)**

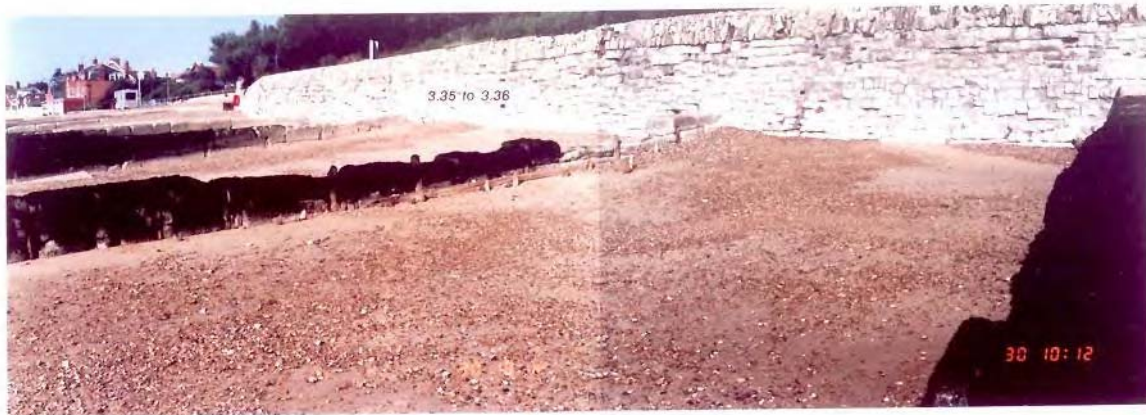
**Figure 2-3 Beach level at Cobbold's Point in 1991 (Shoreline Management Partnership)**

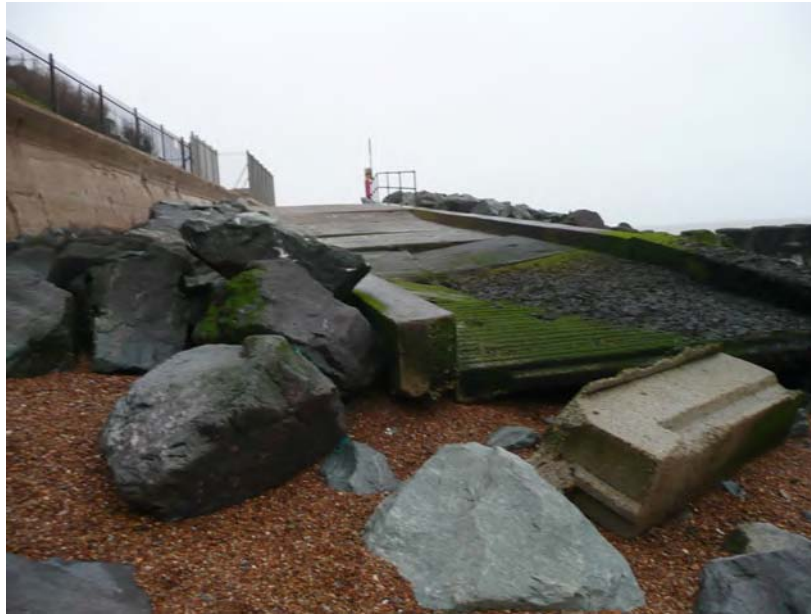
**Figure 2-5 Collapsed access slipway at Cobbold's Point.**

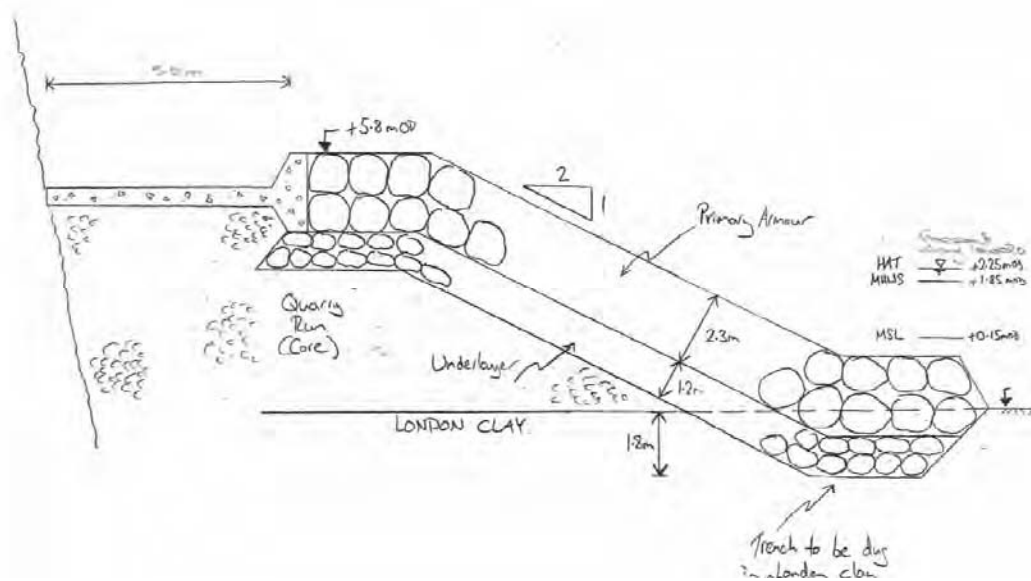
**Figure 4-2 Cross section through the proposed rock revetment and walkway**
