Beach, Groynes and Sea Wall At Holland-on-Sea

Jeremy Shiers
June 2012

Draft 0.1

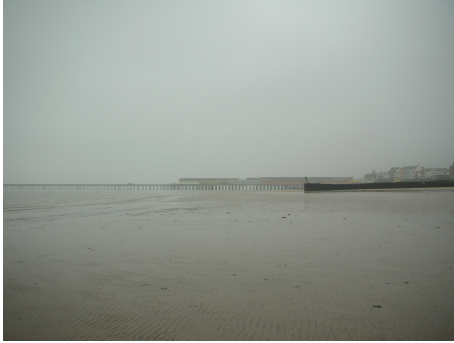
Figure 1: Walton Beach

There is clear difference in the state of beach at Walton, Holland and Clacton south of the pier as the following pictures show. All these pictures were taken between 8:30 and 9:30am on 9 May 2012 when there was a particularly low tide.

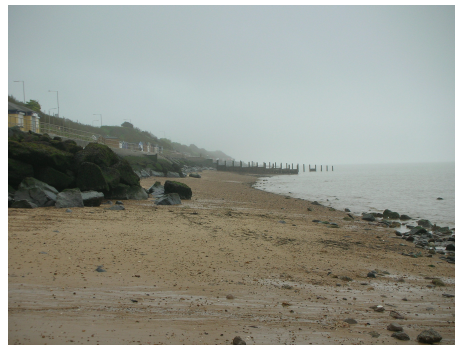
Figure 4: Flags Cafe

Bad as things are at Holland Haven things are even worse near Flags Cafe.

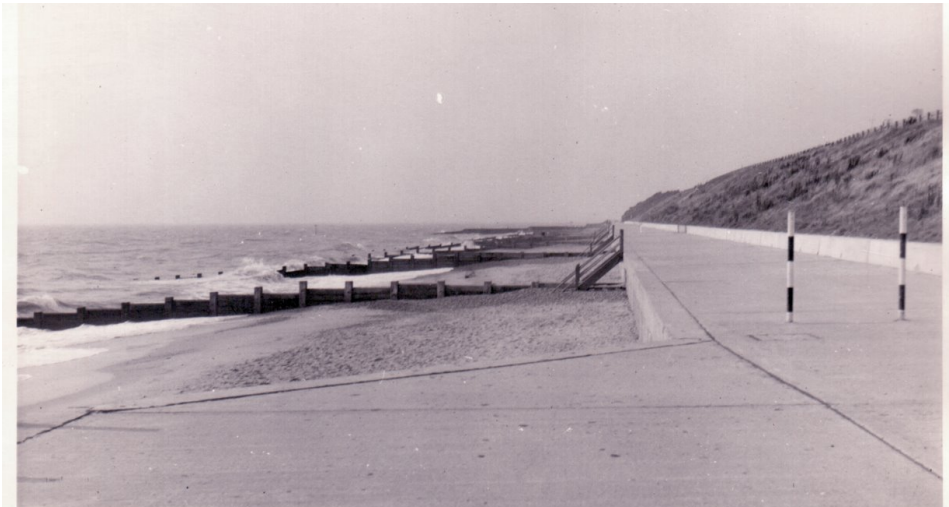
Figure 7: Holland Haven Decades Ago

Here are 2 pictures of the beach at Holland Haven near Pat's Cafe and the sailing club.

In the 60's or 70's there was clearly a much better beach. The groynes were almost entirely buried in sand.

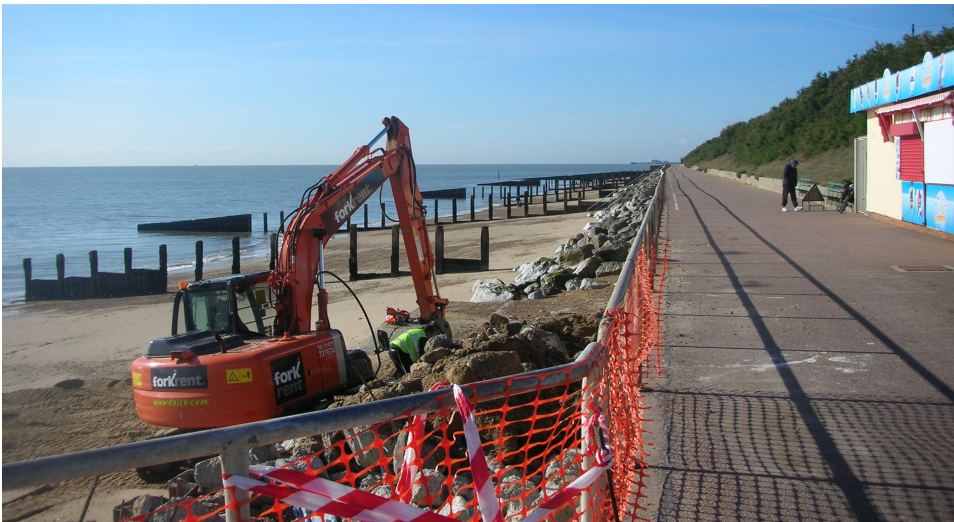
Figure 8: Holland Haven Now

Now the groynes are in terrible state after years of neglect and the level of sand has dropped dramatically.

Figures 3 and 8 show the effect of these 'repairs'.

And they remember the sea washing them away on the first high tide, presumably because the groves had been widened so much they no longer function.

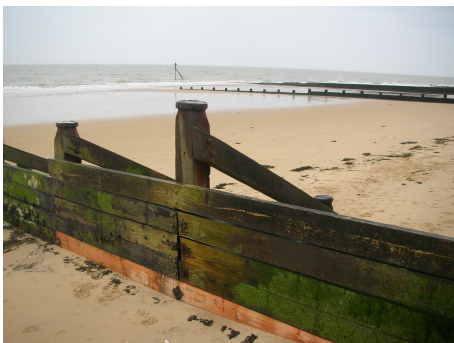
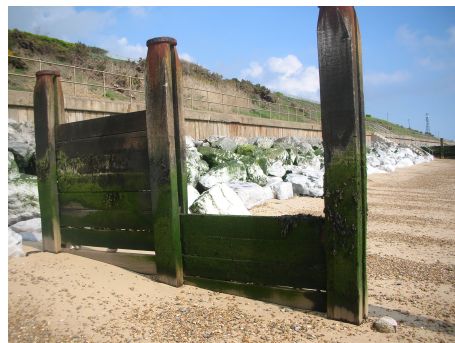
Figure 9: Walton Planks Bolted On Figure 10: Holland Planks In Groves

Worse the horizontal planks are bolted to the uprights at Frinton and Walton, at Holland and Clacton they are slotted into groves in the uprights. This will be a much weaker way of retaining the planks. The sea will wiggle the planks which will widen the groves. Eventually the planks will simply fall out of the groves.

Whatever the historical reason there is no justification for continuing with the failed system at Holland, especially as the two Urban District Councils have been absorbed into TDC.

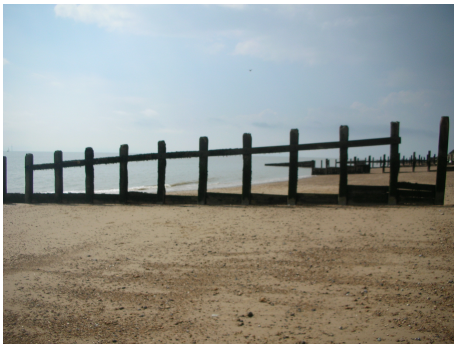
Figure 11: Holland Top Plank Bolted

At Holland there are some boards which have been bolted onto the top of the uprights and are still there.

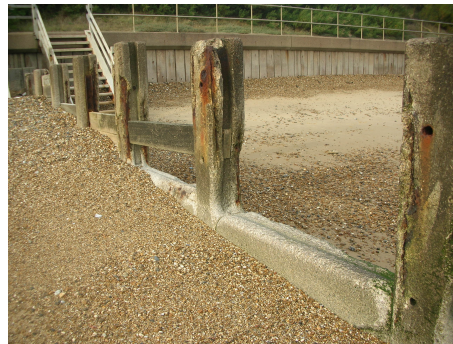
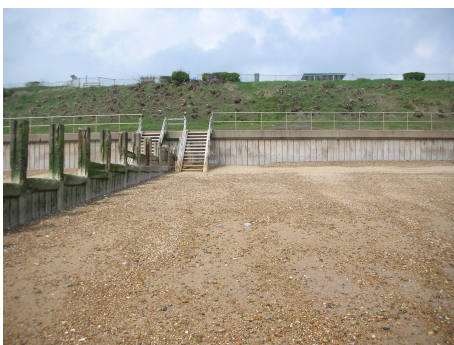
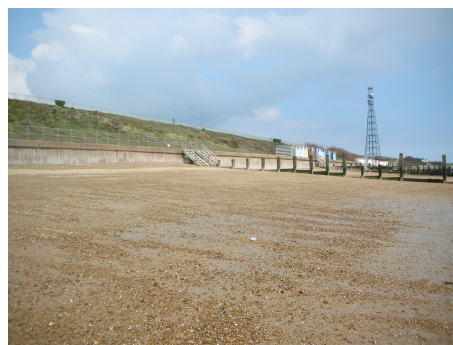
Despite the poor state of the groynes at Holland where there are horizontal planks they trap sand and shingle.

But only if the horizontal planks extend down to at least the level of the sand.

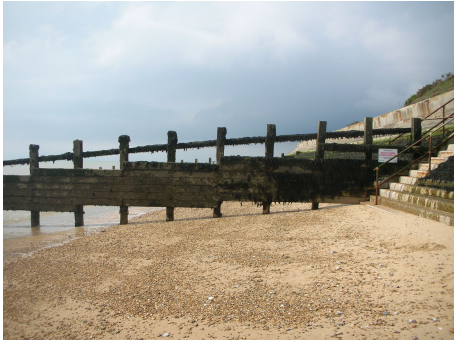
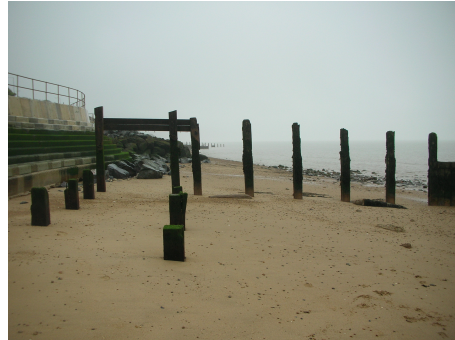
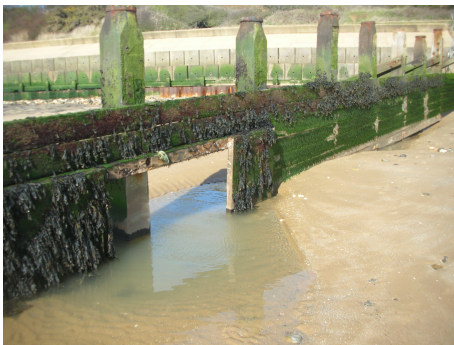
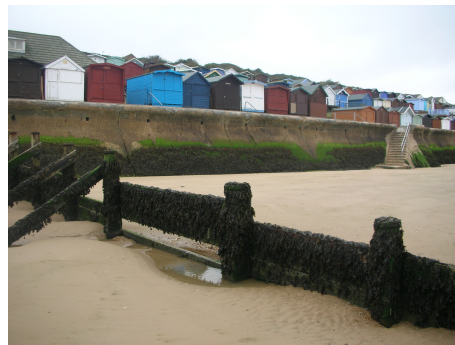
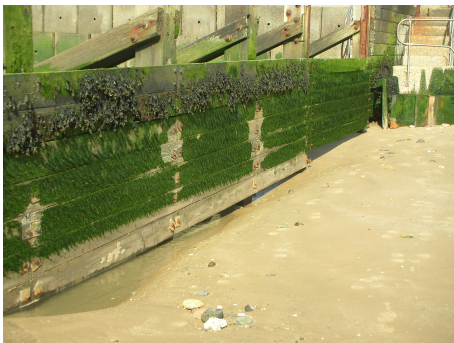
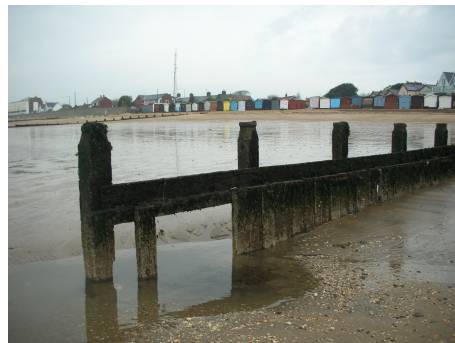
There are some groynes with missing horizontal planks at Frinton and Walton and this causes erosion.

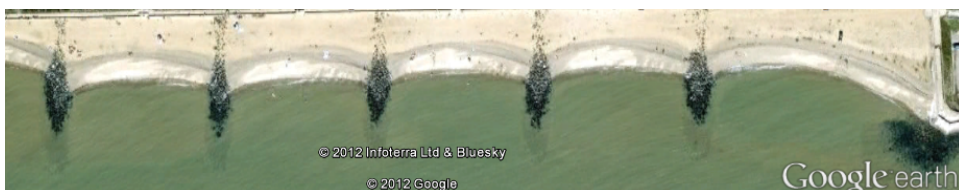
Figure 21: Rock Groynes Seawick

The Seawick groynes are working well and these are 53m length 14m wide at the base and have a spacing of 78m. If they prove not to be long enough they can always be extended later (at greater cost of course).

Clacton Pier to Holland Haven appears to be about 5.6Km so 72 groynes seem to be the requirement and at £0.2million each this would cost about £14million.

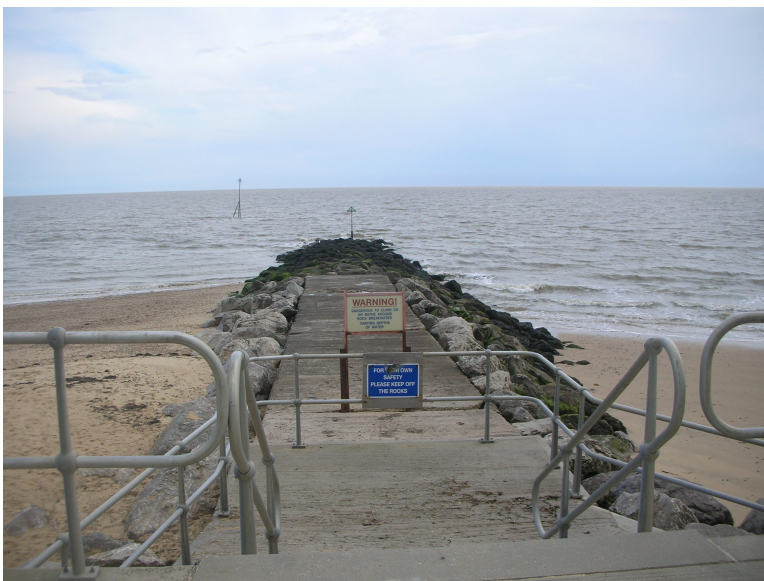
Figure 22: Higher Sand North Groyne 84

There is such a bank of dry sand to the north of groyne 84 at Eastcliff in Walton.

Although there is a good beach at Frinton Richard feels the groynes were not designed correctly. In his opinion all groynes should rise to MHWS plus at least 1 meter no closer than 5 meter from the seawall and then run level, or just a gentle slope, to the seawall. And then there will be a bank of dry sand in front of the sea wall.

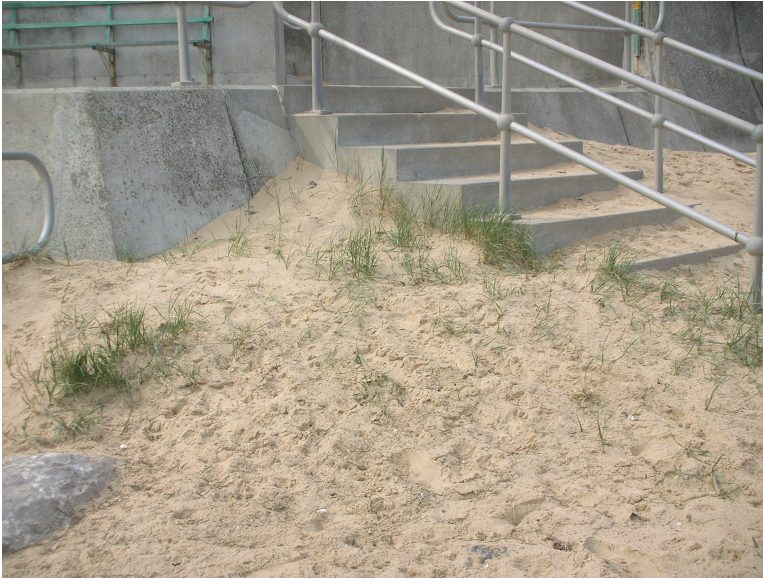
Figure 23: Grass Growing By Groyne 84

And it's been there so long grass has grown.
